Fabrication of Ceramic Substrate- Reinforced and Free Forms

**R.J. Quentmeyer, G. McDonald,
and R.C. Hendricks**
*Lewis Research Center
Cleveland, Ohio*

Prepared for the
12th International Conference on Metallurgical Coatings
sponsored by the American Vacuum Society
Los Angeles, California, April 15-19, 1985

1. Report No. NASA TM-86994		2. Government Accession No.		3. Recipient's Catalog No.	
4. Title and Subtitle Fabrication of Ceramic Substrate-Reinforced and Free Forms				5. Report Date

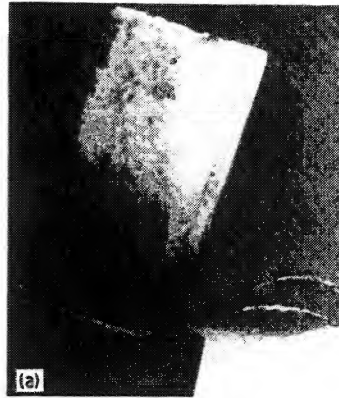
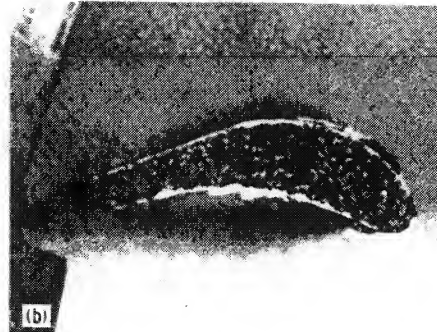
Figure 1. - Prof. Schmidt's experimental ceramic vanes and blades.

- (a) Structure of porcelain enamel compliant core.
- (b) Closeup of shell and compliant core structure.
- (c) Turbine blade configuration and experimental ceramic blades.

In the early 1940's, Ernst Schmidt¹ was fabricating ceramic turbine blades of two basic types: a hollow core with coolant passages, and a membrane over a compliant porous substrate (Fig. 1). Apparently Schmidt recognized four basic needs: low thermal conductivity, a smooth exterior surface, blade cooling, and a strain relief mechanism.
